**PISCATAQUA RIVER BASIN  
MILTON , NEW HAMPSHIRE**

**MILTON LEATHER BOARD DAM  
N.H. - 00316**

**PHASE I INSPECTION REPORT  
NATIONAL DAM INSPECTION PROGRAM**

**FEBRUARY 1979**

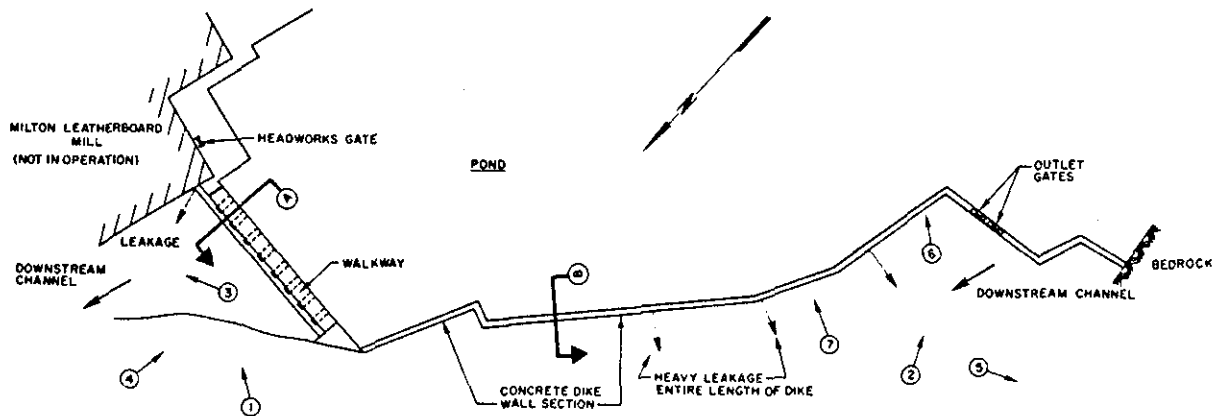
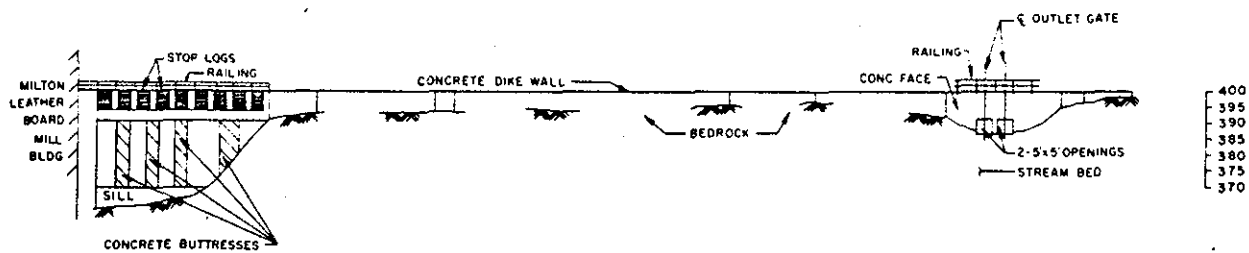
EDWARD C. JORDAN CO., INC. PORTLAND, MAINE		U.S. ARMY ENGINEER CORPS PORTLAND, MAINE	
NATIONAL PROGRAM OF INSPECTION OF NON-FED DAMS			
MILTON LEATHERBOARD DAM			
PLAN & PROFILE			
SALMON FALLS RIVER			N.H.
SCALE		DATE

The following plan, profile and cross-section sketches of the dam were developed from a limited stadia survey performed during visual inspection, field notes taken by inspection team members, and photographs taken during the visual inspection. The survey was referenced to an arbitrary local datum. Approximate U.S.G.S. elevations were obtained by adding 300.0 feet to the local reference.
